**METHYL BROMIDE MEASUREMENTS ON 10 AND 11 JUNE 2000,
CONDUCTED DURING FUMIGATION AND DE-GASSING OF STACKED
PALLETS OF COCOA BEANS IN TWO WAREHOUSES IN AMSTERDAM**

On behalf of Mr W. Veldman, VROM Inspectorate *regio Zuid-West*

Report number 609021046

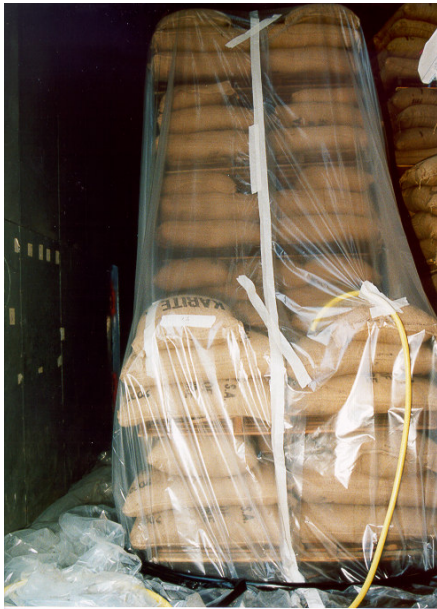
On 10 June 2000, stacked pallets of cocoa beans were fumigated in two warehouses of the Fa. Schutte in Amsterdam. To this end, the stacked pallets with bales of cocoa beans were covered with a "tent" of plastic film, which reached to the floor with some overlap. To ensure an airtight seal with the floor, water-filled tubes were placed on top of the plastic film. These stacked pallets of goods covered with an airtight "tent" are called *klampen* in Dutch. These tents were then fumigated by making a hole in the film through which a hose was inserted; the opening around the hose was sealed and then methyl bromide gas was injected into the tent using a vaporizer (see Figure 1).

Figure 1: Fumigation of stacked pallets of cocoa beans

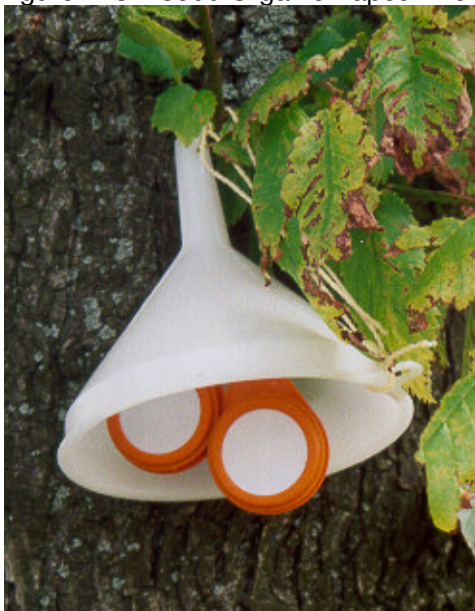
Materials: 3M 3500 organic vapour monitor (see Figure 2).

Figure 2: 3M 3500 Organic Vapour Monitor (adsorption badges)

During the fumigation phase, adsorption badges were exposed to the air at locations A, B, C and D. Before the tents were cut open, the badges at all locations were replaced by new badges, which were then exposed to the outside air during the de-gassing phase for approximately 4 hours.

The results obtained from samples taken with the adsorption badges and the active charcoal tubes that were taken at the same location during the same time period show significant differences, where the concentrations of methyl bromide in the air shown by the badges are lower or much lower than those obtained with the active charcoal tubes. It is possible that methyl bromide is adsorbed less onto active carbon during passive sampling than during active sampling; passive sampling could therefore lead to an underestimation of the methyl bromide concentration in the air.

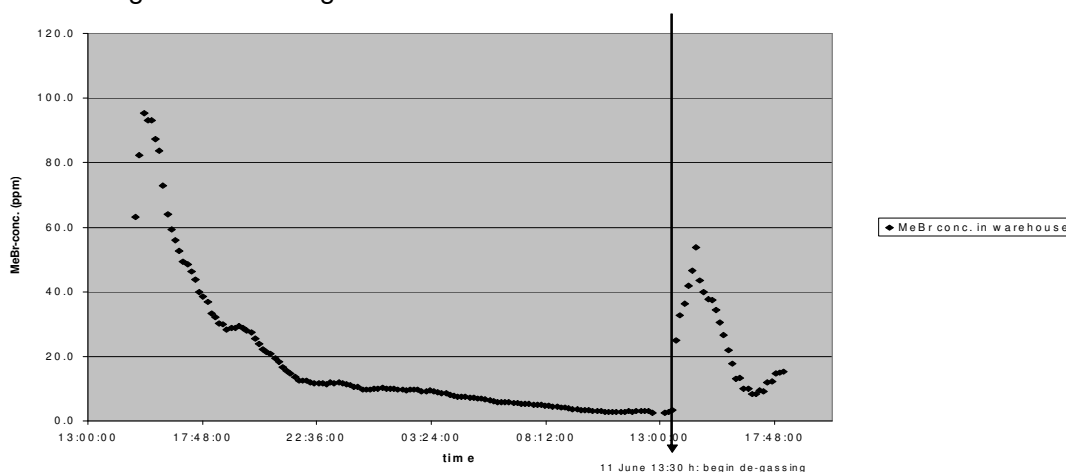
In Figure 4, the results of the Photovac 10SPlus are shown on a graph, converted to hourly average values for both the fumigation phase and the de-gassing phase.

Figure 4: Concentration of methyl bromide in warehouse with tent-covered stacks of cocoa beans during and after fumigation

The results of the measurements with the Photovac 10SPlus showed that the plastic tents were not airtight: immediately after the methyl bromide was injected, the gas concentration in the warehouse increased rapidly. After this, the concentration fell to approximately 2 ppm during the period that the plastic tents were filled with gas.

After the plastic tents were cut open, the methyl bromide concentration in the air in the warehouse, which had stabilized during the fumigation period, rose to a peak concentration of approximately 50 ppm ($\approx 200 \text{ mg/m}^3$).
